Statistical overview of findings by IR-inspections of PV-plants

Claudia Buerhop^{*a}, Tobias Pickel^a, Hans Scheuerpflug^a, Christian Camus^a, Jens Hauch^a, Christoph J. Brabec^{ab}
^aBavarian Center for Applied Energy Research (ZAE Bayern), Haberstraße 2a, 91058 Erlangen, Germany
^bi-MEET, FAU Erlangen-Nürnberg, Martensstraße 7, 91058 Erlangen, Germany

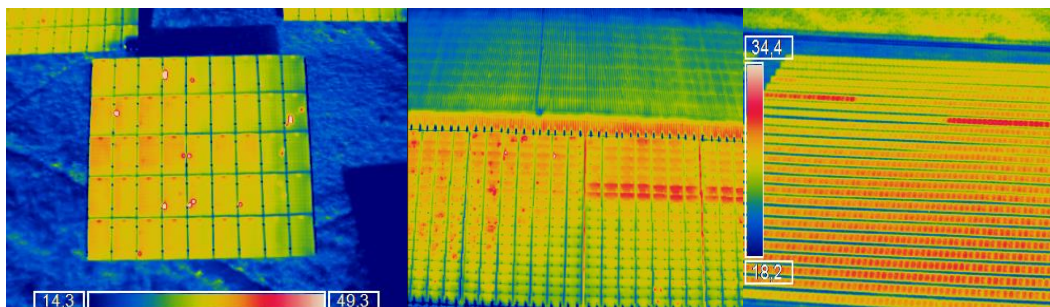
Figure 1: IR-images of different PV-plants showing certain numbers of sites with elevated temperature, left: tracked PV-table with 12 out of 45 modules showing IR-abnormalities, center: industrial roof with numerous defective modules and two suspicious module strings, right: IR-overview of a field installation with two suspicious module strings

without operation interruption [12-14]. Electrical malfunctioning modules show up in the IR-image because of their elevated temperature [15]. Typical IR-images of three different installations are presented in Figure 1. Here, module and string failures can be distinguished. A module failure normally shows single sites (small spots, individual cells, cell arrays typically protected by a bypass diode, so called substring) of increased temperature within the module. String failure is typically caused by a cabling problem of installed PV-modules, e. g. the connection to the inverter is interrupted. The modules within the string are at open circuit. No current flow is possible, all absorbed solar irradiance is transferred to heat. Therefore all these modules show a homogeneously higher temperature.

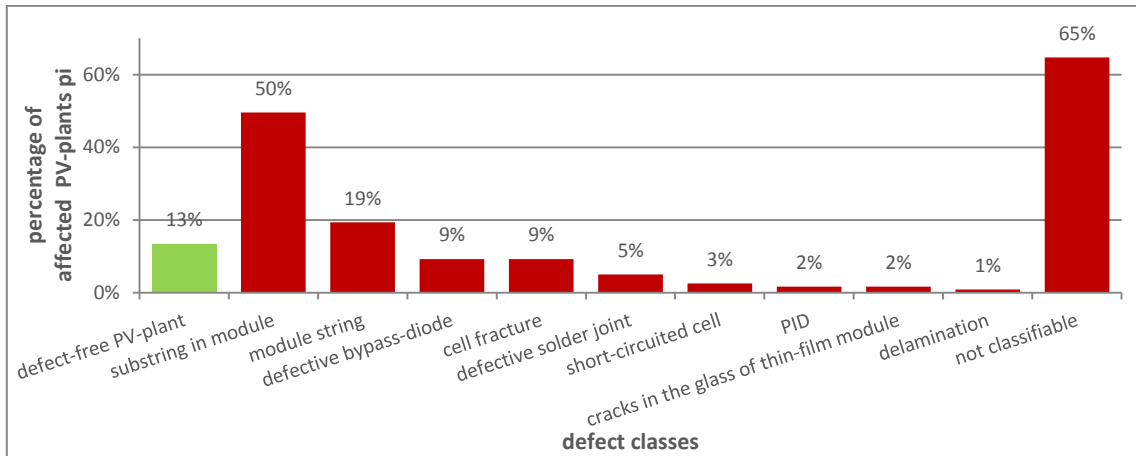
Based on their temperature distribution the IR results were assigned to failure modes identified by their characteristic IR-fingerprint as described in [15]. The occurrence of the specific IR-findings or failure modes in PV-plants differs strongly, see Figure 2. Only 13% of the PV-plants exhibited no IR abnormalities. Surprisingly, approximately 20% of the PV-plants show more than one complete *suspicious module string* (compare Figure 1 center and right). Possible reasons for the disconnection may be wrong installation or deterioration by animals or natural degradation. Approximately 50% of the PV-plants have *bypassed substrings*.

Figure 2: Distribution of the most frequent findings in IR-images

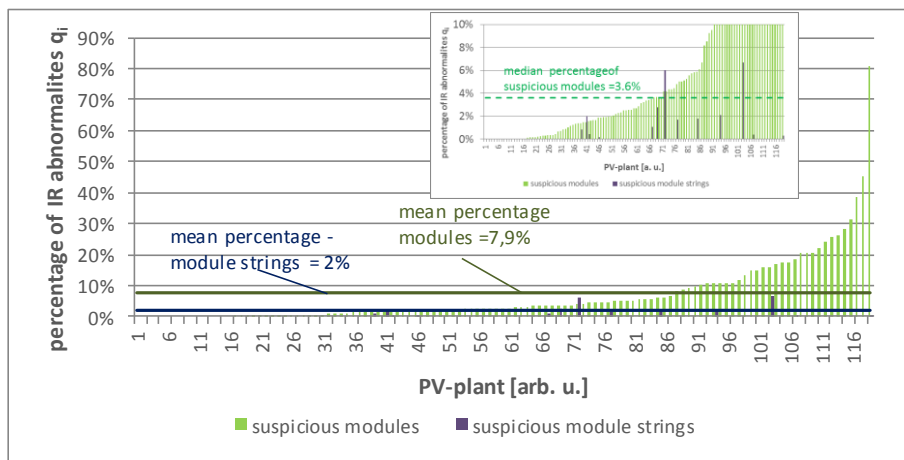
Figure 3: a) investigated PV-plants overview of inspected PV-plants sorted in ascending order of percentage of IR abnormalities. b) Zoom in into range of failure rates up to 10% abnormalities.

The calculated failure rates q_i of the inspected PV-plants are presented in Figure 3 sorted with ascending sequence of failure rate of modules (including all kinds of defects) and strings. Highest frequencies of suspicious modules were detected for PV-plants with delamination (80% of the modules are affected), or PID (35% and 40% of the modules showed the signature). In the remaining PV-plants other typical features were observed in lower numbers. Mean percentage and median percentage of failure rates are listed in Table 3 for modules and strings. Mean and median for modules differ strongly due to high failure rates in a few inspected PV-plants with PID and delamination.

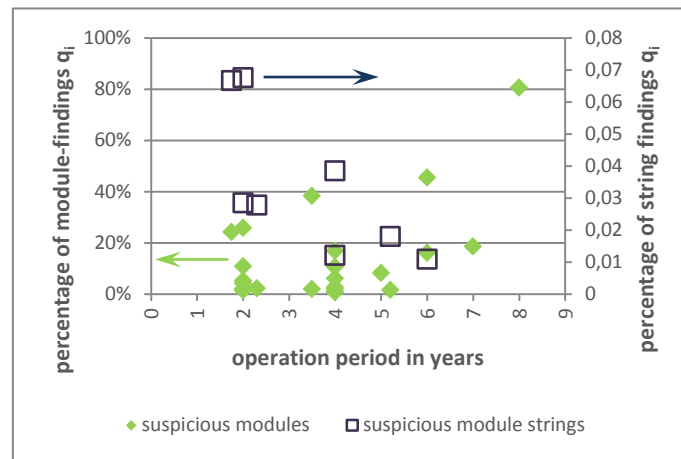
The influence of the operation duration prior to investigation on the failure rates of modules and strings as they have been detected by IR-inspection, are shown in Figure 4. Neglecting the high failure rates for PID and delamination a fairly constant percentage of suspicious modules is found. An expected increase of IR-findings for longer operating PV-plants could not be confirmed by the selected PV-plants. Since the history of the PV-plants is not entirely documented and known, possible module replacements and other repowering activities during life-cycle may falsify the statistics. The evidence for disconnected module strings is fairly high (7%) at the beginning of life-cycle and decreases with operation time.

Figure 4: Percentage of thermal findings as a function of operation time

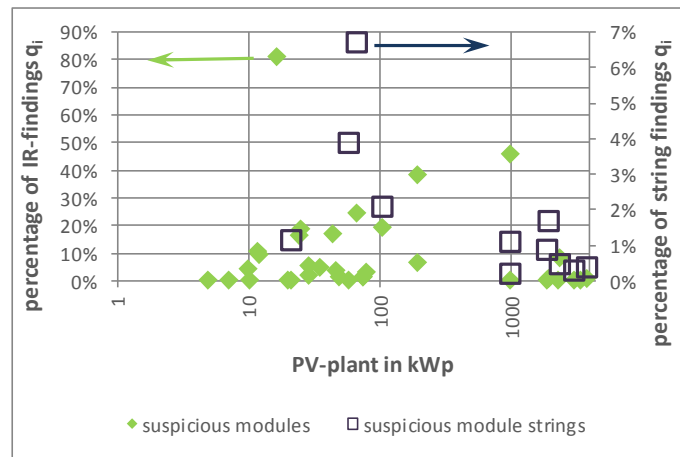
The module failure rate increases but spreads with plant size up to 200 kWp. For large PV-plants (> 1 MWp) it is constant at a fairly low level, less than 10%.

Small and medium-sized PV-plants (with few strings due to the limited number of modules) show rarely string failures, see also 3.5, whereas it is quite often detected in MW-plants. Although the occurrence for string findings is rather high in large PV-plants, the percentage drops. Thus, a constant number of module strings at open circuit is observed.

Figure 5: Percentage of IR-findings (modules and strings) as a function of PV-plant power output

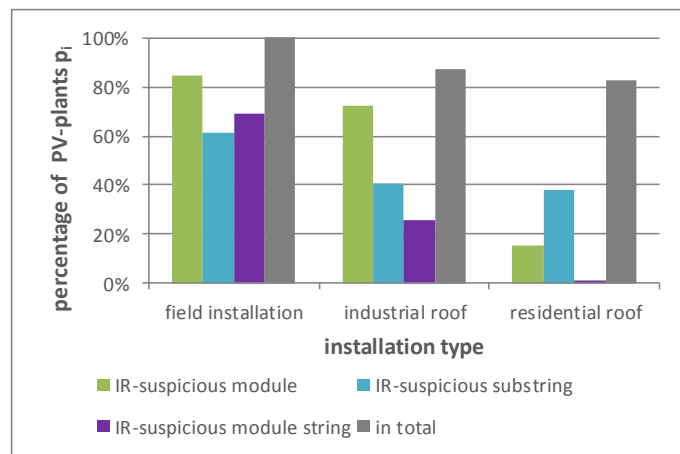
As figure 6 illustrates nearly all (> 80%) PV-plants of any type show IR-findings.

Figure 6:: Frequency of PV-plants with IR-findings differentiating between suspicious modules, substrings within modules and module strings for different installation locations

The probability to detect modules, substrings and module substrings is much higher for large field and industrial roof installations than for rather small residential roof installations. Unconnected modules strings were only counted very

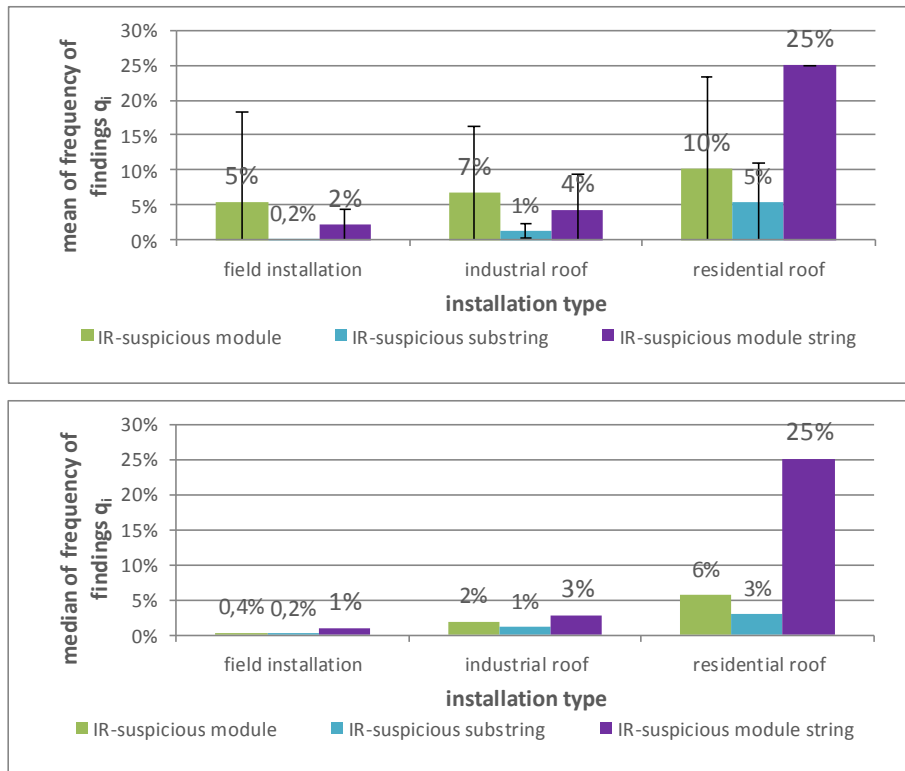
Taking the average of all affected installations for all installation types 8,0% suspicious modules, 2,9% substrings and 4,2% module strings are detected. Figure 7 shows that the mean frequency for suspicious strings differs considerably for large versus small installations. Note, that only one house installation in the evaluated sampling showed one irregularly heated module string (figure 6). Typically two to four unconnected module strings are detected in large installations. The mean frequency for substring findings is significantly higher for residential installations than for large installations. Considering the detection of suspicious modules, no significant deviations between the installations were found. However, substring and module failure rates of residential installations are higher than the average values.

Large error bars of the calculated mean value indicate the diversity of the plants investigated. In order to get a better understanding of the data, the median is determined, too. The median and the mean value for suspicious substrings correspond fairly well. However, Figure 7 shows clearly that the median for the modules and the module strings are well below the mean value. Here, just a few PV-plants with quite high rates of defective modules showing up in the IR-image push the mean to high values. Such PV-plants may be affected by severe module failure mechanisms, as e. g. potential induced degradation (PID) or delamination. As PID is a fairly young module fairly not many PV-plants have been inspected to date. However, when PID and delamination are present, a very large number of modules is PID-affected and shows up in the IR-image, because of the intrinsic failure type properties.

Figure 7: Frequency of IR-findings in the affected PV-plants, mean of frequency (top) and median of frequency (bottom) for different IR-findings (module, substring and module string) and three installation locations
