Review of Failures of Photovoltaic Modules

Report IEA-PVPS T13-01:2014

Performance and Reliability of Photovoltaic Systems

Subtask 3.2: Review of Failures of Photovoltaic Modules

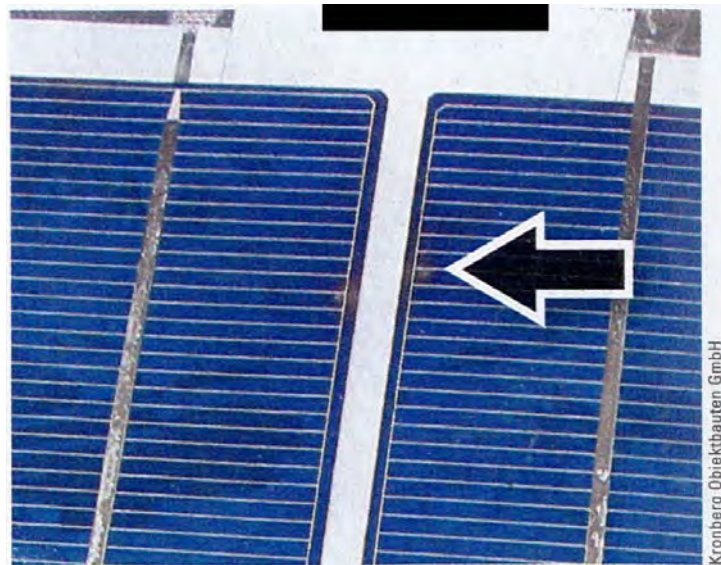
Fig. 4.2.1: Brown marks at the edge of the solar cell are no failure.

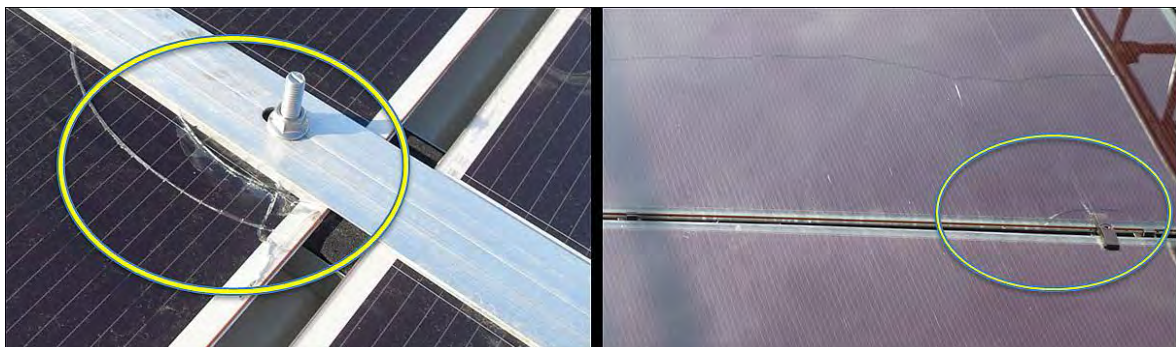
Fig. 4.3.1: Left figure shows glass breakage caused by too tight screws and the right figure a PV module that broke due to poor clamp design.

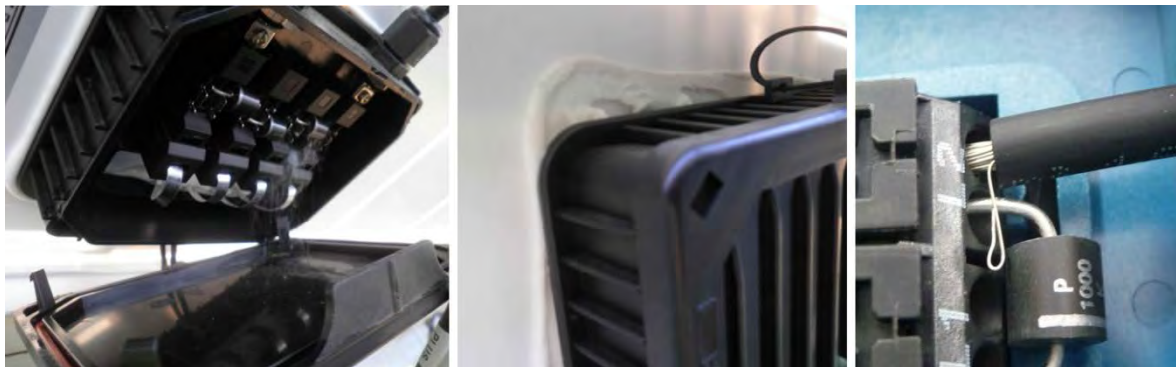
Fig. 6.1.3: Junction box failures: Left photo shows an open junction box in the field, the middle one a poorly bonded JB on the backsheet, and the right one a JB with poor wiring.

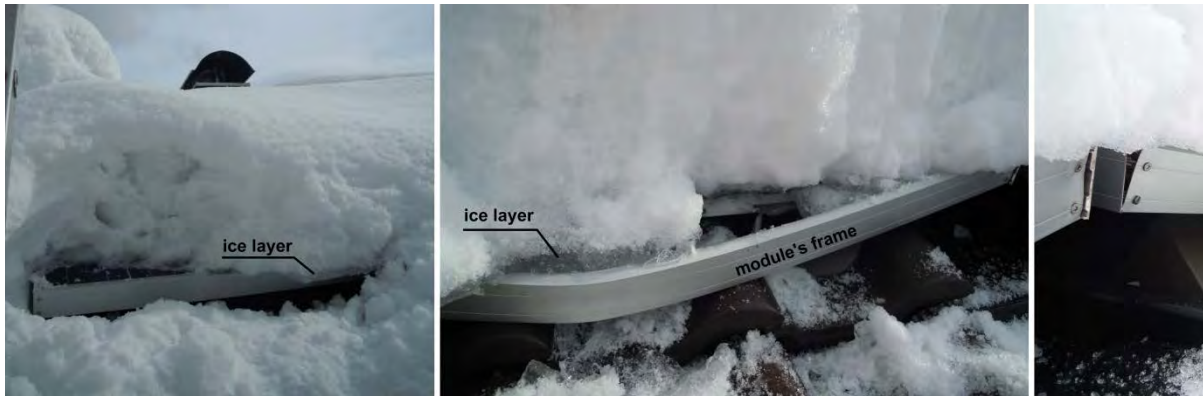
Figure 6.1.4: Damaged module frames after heavy snow load of 1.2 m, melted down to 35 cm, in winter 2012. Alpine location at 620 m a.s.l., tilt angle 25°. 60 cell modules with dimensions 1660 mm x 990 mm, 50 mm Al-frame.

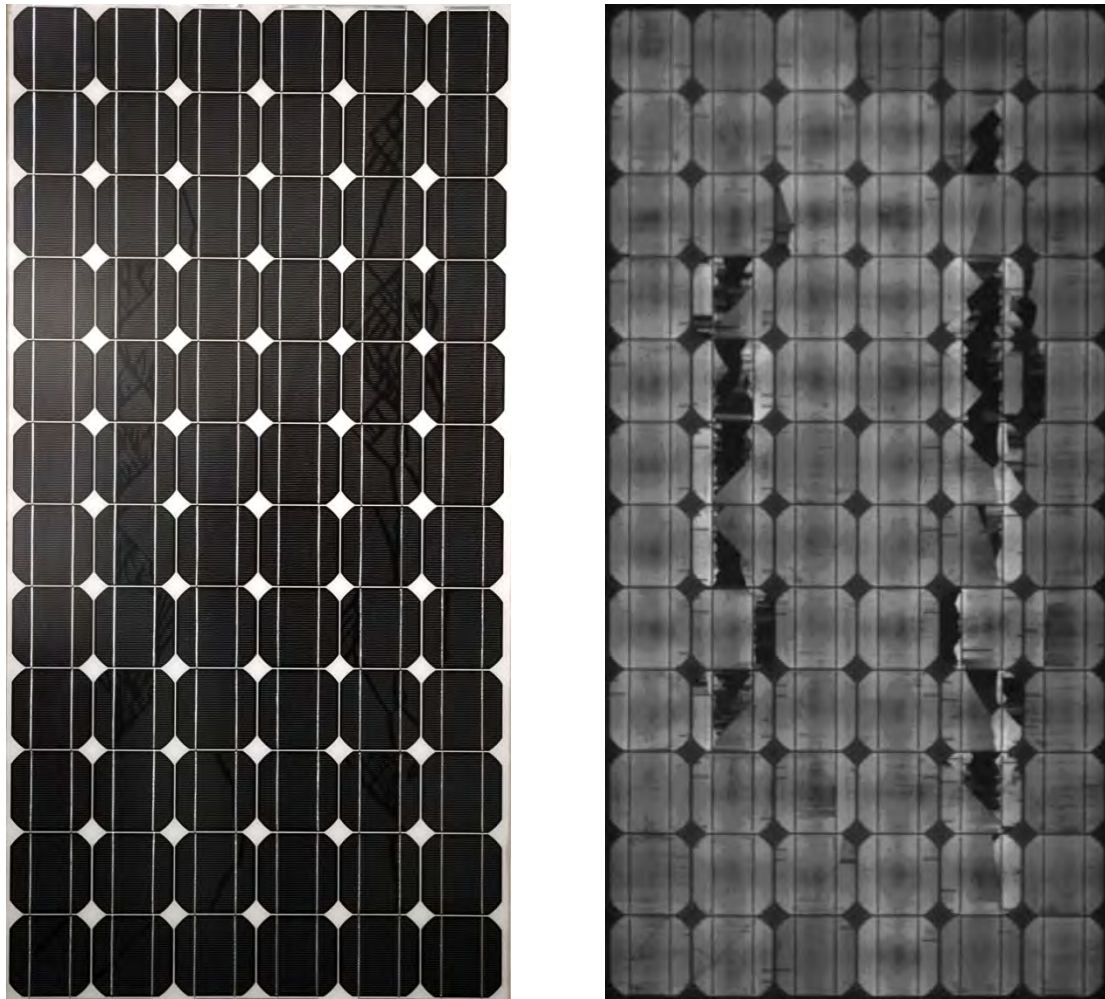
Fig. 6.2.4: Left: photograph of a snail track PV module. Right: EL image of the same snail track PV module. A snail track occurs along the edges of a solar cell and along cell cracks [Koentges08].

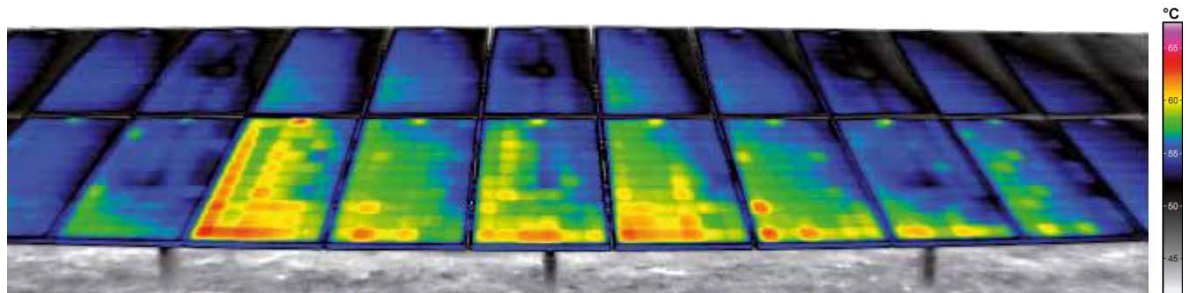
Fig. 6.2.11: Operating module array investigated by thermography under illumination. The negative module voltage decreases from the right to the left side, and the power losses heating the modules in the shunted areas are also increasing from the right to the left [Weinreich13].

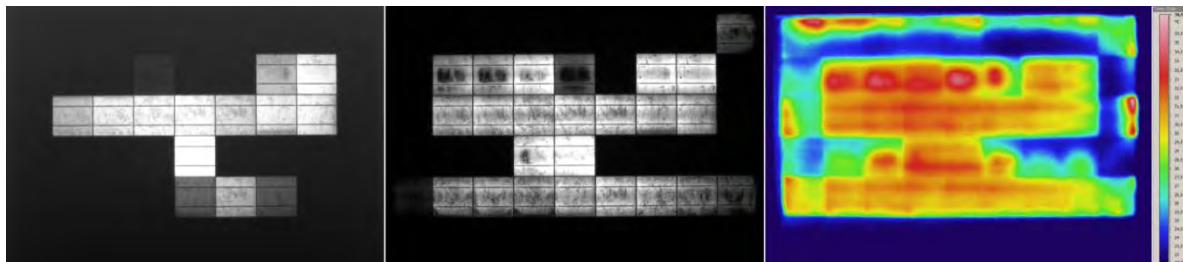
Fig. 6.2.12: Fielded 6×9-cell-module with the I - V curves depicted in Fig. 6.2.7 (b), investigated with electroluminescence images made at 10% I_{sc} (left), 100% I_{sc} (middle) and dark IR thermography at 100% I_{sc} (right) [Berger13].

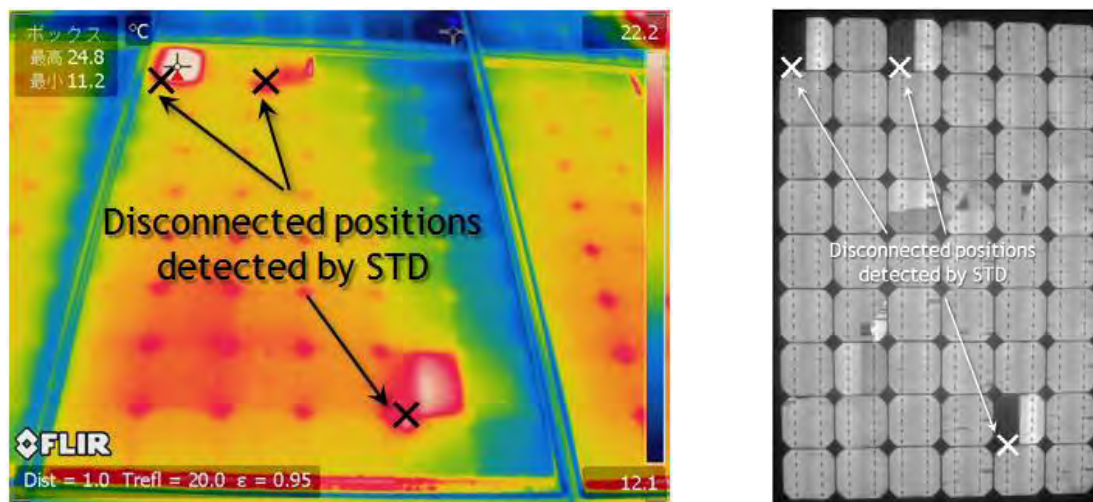
Fig. 6.2.14: Left: An example of disconnected cell interconnections found in the field (IR image). Right: The corresponding EL image of the same PV module.

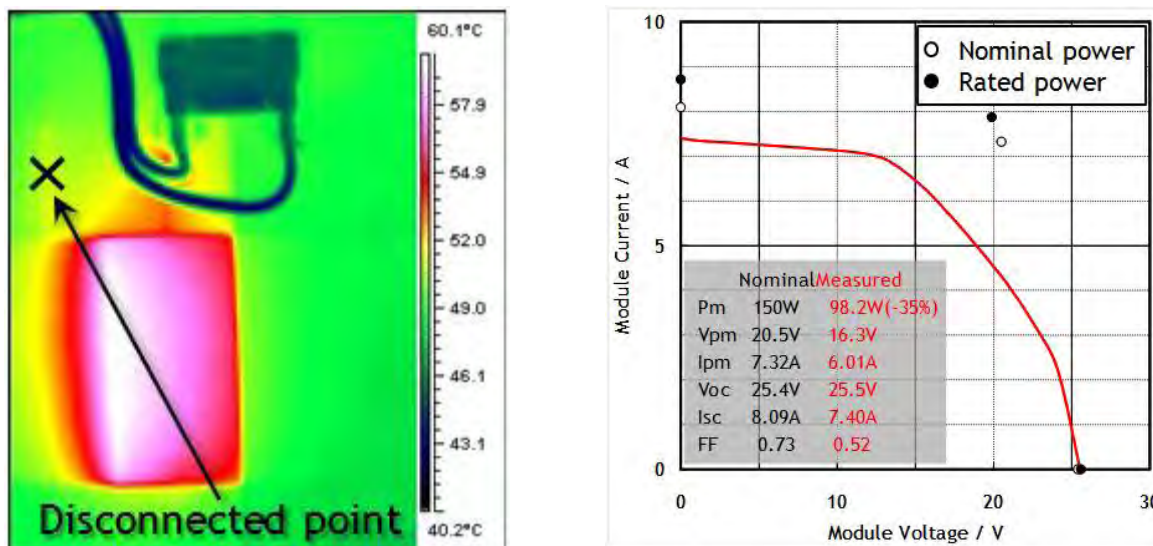
Fig. 6.2.15: Left: an IR image of a PV module where one interconnect ribbon is locally disconnected (“failure stage 1”). Right: I-V curve (indoor STD) of a PV module in which one interconnect ribbon is locally disconnected (“Failure Stage 1”). The Nominal and initial rated I-V curve parameters are plotted into the graph.

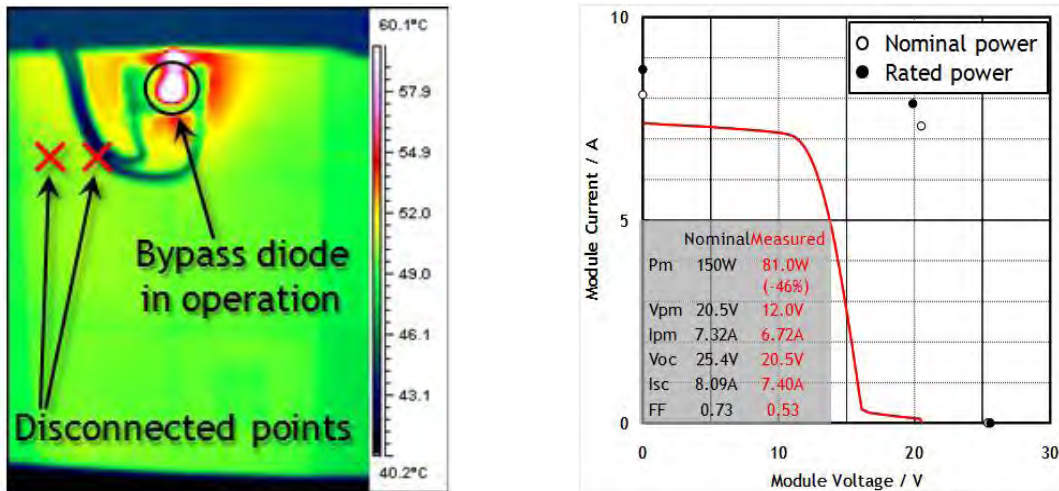
Fig. 6.2.16: Failure stage 2. Left: an IR image of a PV module with two parallel cell interconnect ribbons locally disconnected. Right: I - V curve measurement (indoor STD) of PV module with two parallel cell interconnect ribbons locally disconnected.

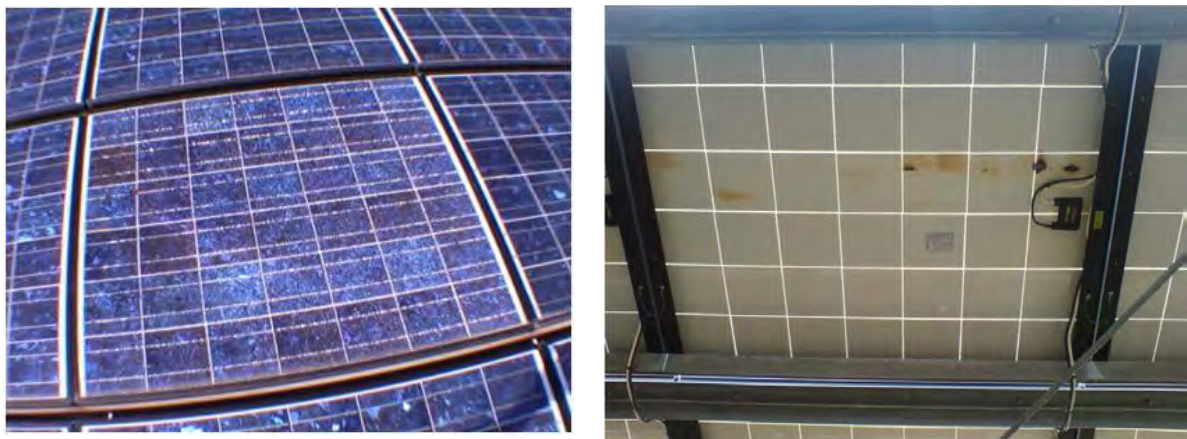
Fig. 6.2.17: Final stage. Left: glass breakage of a PV module caused by broken cell interconnect ribbons. Right: burn marks on the PV module rear side caused by broken cell interconnect ribbons.

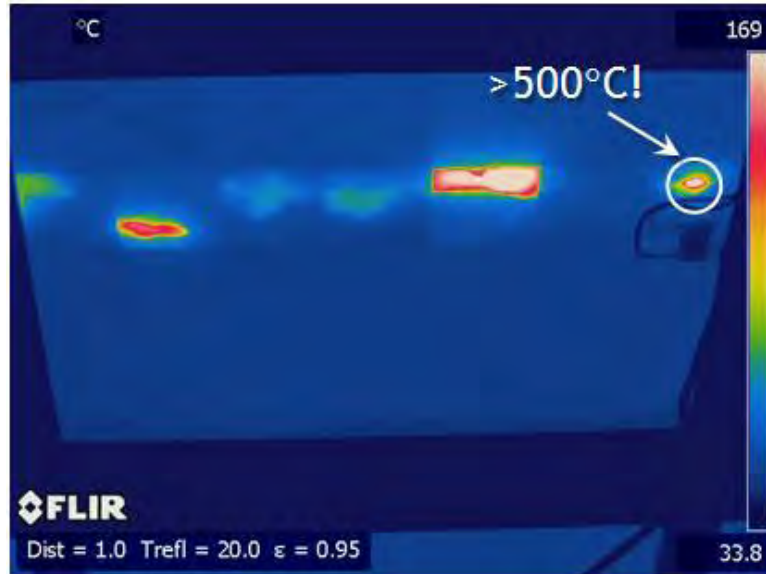
Fig. 6.2.18: An IR image of the “final stage” PV module (observed from rear side).

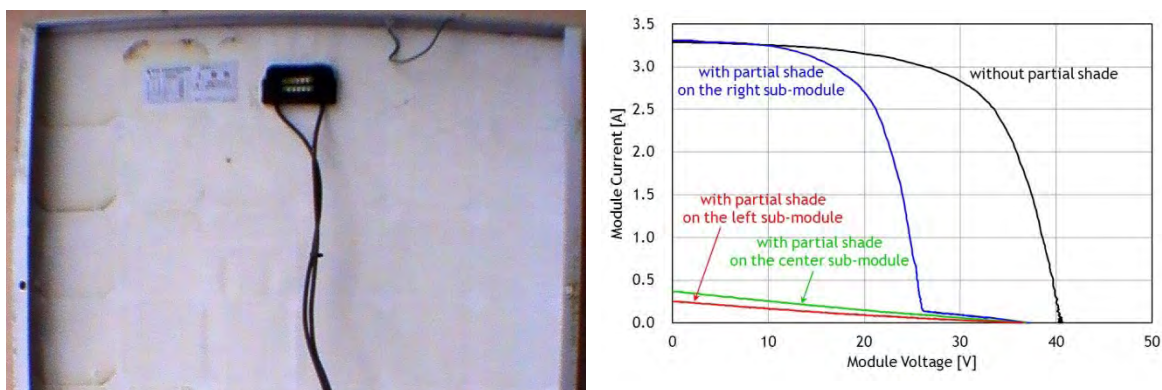
Fig. 6.2.20: A rear side view (left) and a measured I - V characteristic curve (right) of a PV module with burn marks.

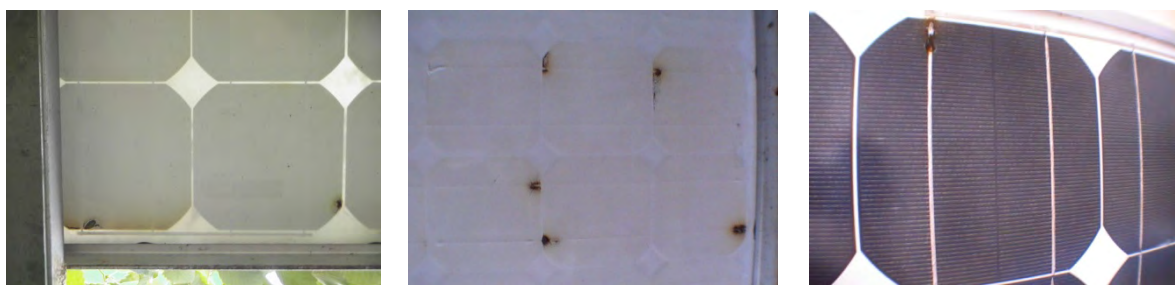
Fig. 6.2.22: Burn marks caused by open-circuit bypass diodes.

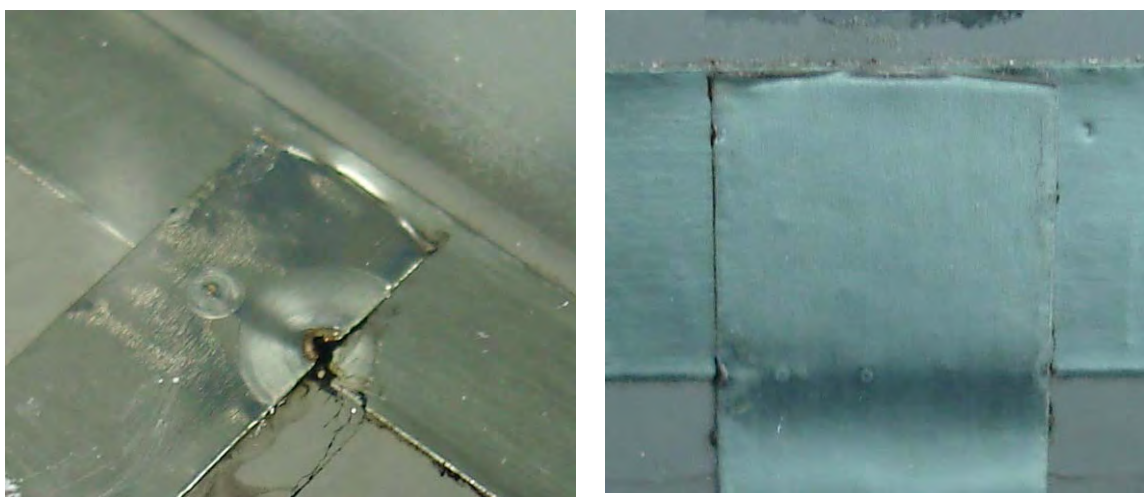
Fig. 6.3.1: Micro arcs which occur if the conductive glue on the string interconnect has an insufficient contact.

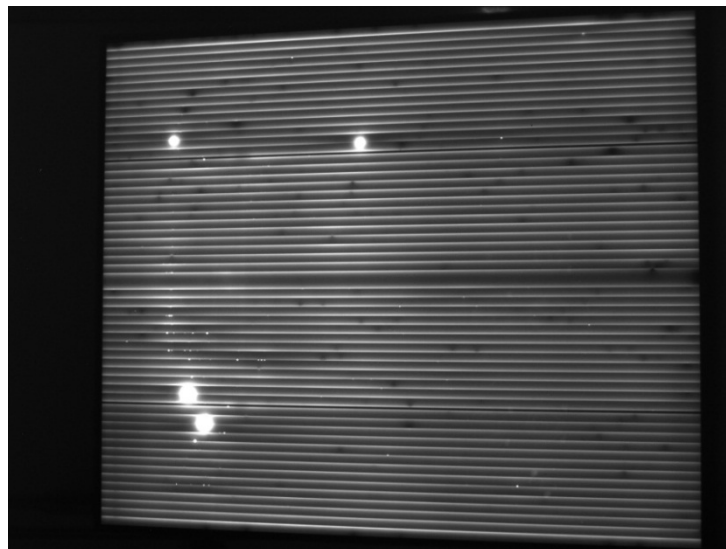
Fig. 6.3.2: Electroluminescence image of an a-Si thin-film module. Dark areas are shunts originating from the production process (type A shunt). Bright spots are severe shunt paths formed by hot-spot operation (type B shunt).

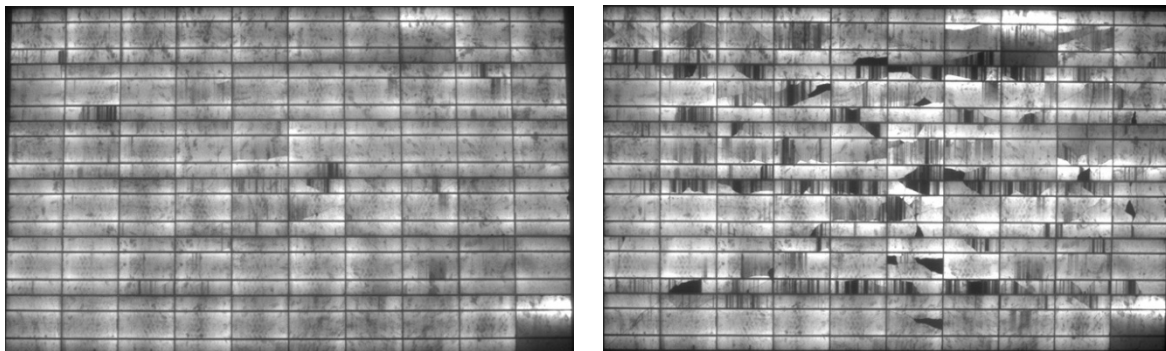
Fig. 7.1.1: Electroluminescence image before (left) and after (right) resonance search.
