Review of Failures of Photovoltaic Modules

Report IEA-PVPS T13-01:2014

Performance and Reliability of Photovoltaic Systems

Subtask 3.2: Review of Failures of Photovoltaic Modules

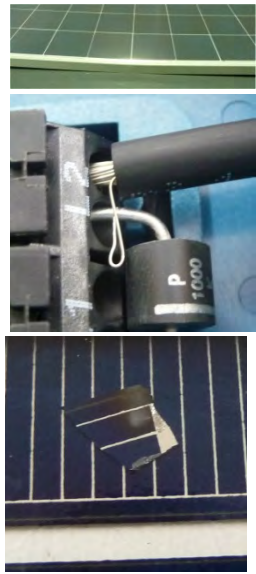
6.2.2, 6.2.3	Crack in cell - a propagation which could remove more than 10% of the cell area from the electrical circuit	A	<u>D</u>

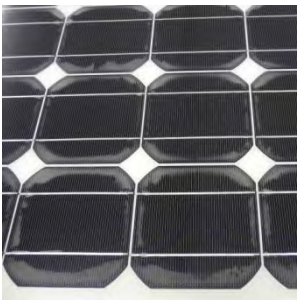
6.1.1	Delamination of c-Si module	B(e)	<u>D/E</u>

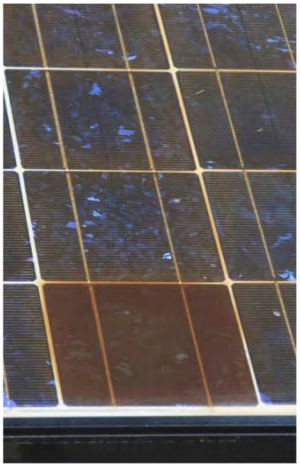
6.2.1, 6.2.2	Browned EVA on top of a cell with two cracks in a cell. Photobleaching takes also place along cell cracks therefore the crack is visible. The browning takes several year to appear. This may not be mistaken for Snail tracks.	B(f)	<u>C</u>

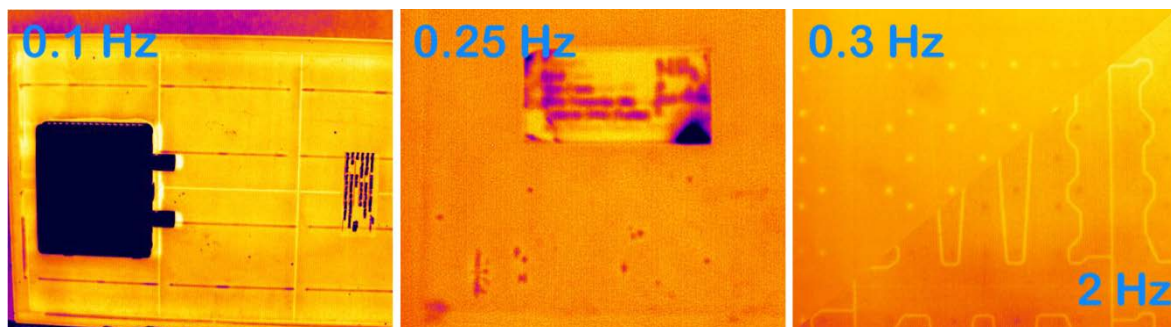
Chapter	Description	Safety	Power	Image
5.1	Allows quasi “visual inspection” of underlying layers and structures through opaque back sheet			See left side picture in Fig. 5.3.1
6.2.6	Position of string and cell interconnects. Detection of deficient soldered joints.	B (f,e,m)	<u>D/E</u>	No image available
6.2.6	Position of interconnects in back-contact modules and their connection quality.	B (f,e,m)	<u>D/E</u>	Fig. 5.3.1: upper part in right image
6.1.1 6.1.2	Inhomogeneous material properties detectable. Detects the depth, where bubbles, delamination occur	C(e)	<u>D/E</u>	Fig. 5.3.1: middle image

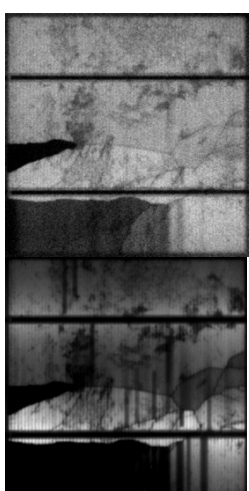
6.2.2	Cross crack line/cross crack	B(f)	<u>A</u>

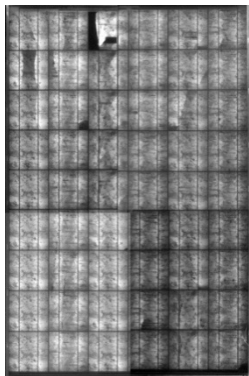
6.2.2	Repetitive induced cell cracks in the production	B(f)	<u>C</u>

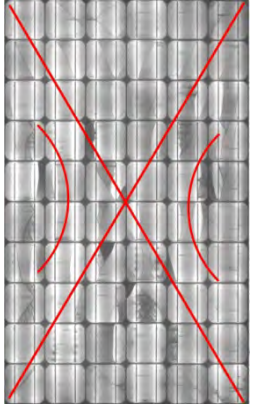
6.2.2	Heavy homogeneous mechanical load. The overall crack pattern in the module looks like a X-crack pattern. The X-crack pattern is visualized in the image by the red lines.	B(f)	<u>C</u>

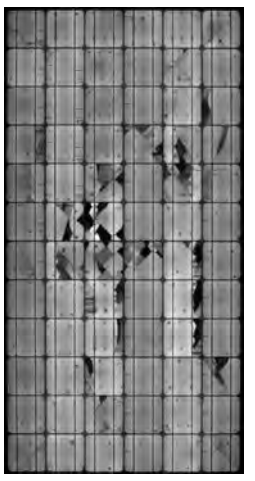
6.2.2	Tilt over PV module. Many dendritic like cracks are located mainly in the cells in the middle of the module.	B(f)	<u>C</u>

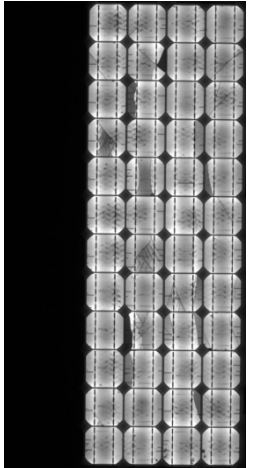
6.2.7	Shunted by pass diode or break in current flow somewhere in the string.	B(f)	<u>E</u>

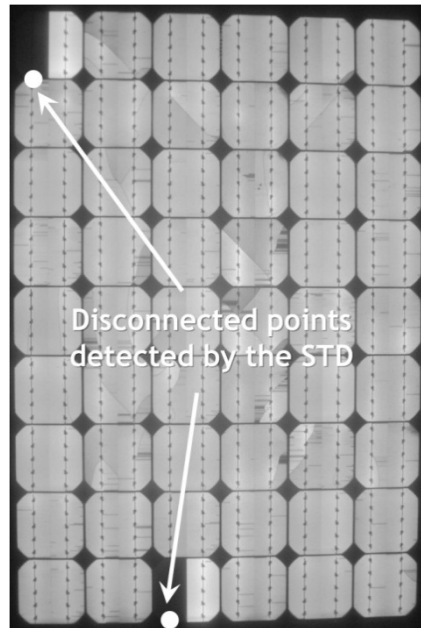
Fig. 5.6.4 is an example of the STD detection of disconnected cell interconnect ribbons in a working PV module. An EL image indicates that two solar cells have disconnected cell interconnect ribbons on the left half of them. The STD detection easily indicates these disconnections of the left-side interconnect ribbons. Table 5.6.1 shows a summary of all failures which are detectable by the STD method.

Fig. 5.6.4: The detection results of the STD detected at a working PV module are inserted into the EL image of the PV module. The EL image indicates that two solar cells, on which finger grids are separated for the two cell halves, have disconnected cell interconnect ribbons on the left half of them. Both results completely match.

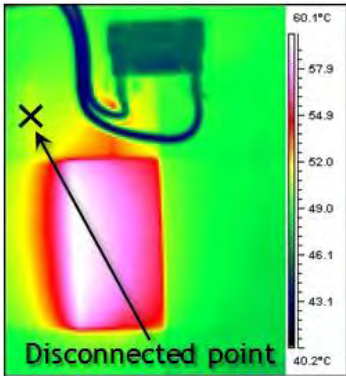
Chapter	Description	Safety	Power	Image
5.3.8	One disconnected cell interconnect ribbon: No signal detected at the disconnected ribbon.	B(f)	<u>C</u>

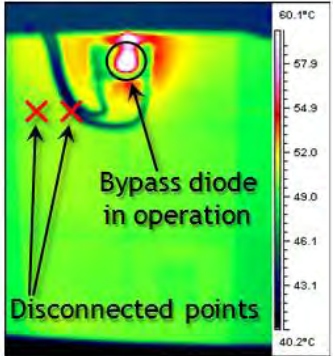
5.3.8	All cell interconnect ribbons of one cell are disconnected or disconnected string interconnect: No signal detected anywhere on the disconnected submodule.	B(f)	<u>E</u>

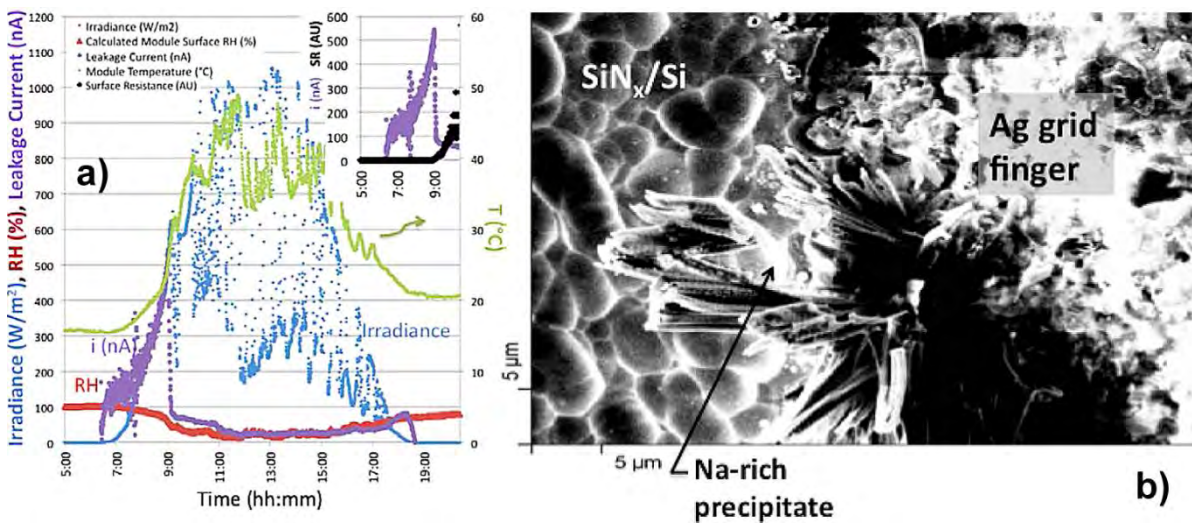
Fig. 6.2.9: a): Irradiance, humidity, leakage current, and temperature during daytime [Hacke11]. b): AES imaging of the SiN_x/Si boundary [Hacke11].

These variable accelerating factors result in the complex variation of the outdoor leakage current as depicted in Fig. 6.2.9 a). Additionally the glass surface conductivity is lowered during rainfall and through pollutants, e.g. salt mist near by the sea. The power degradation in the field may evolve within several months and can reach almost 100%. Figure 6.2.14 gives an example, cf. schematic diagram in Fig. 6.2.7. The fill factor degradation can be modeled with increased second-diode pre-exponential and ideality factor and a decreasing shunt resistance in a two-diode model [Hacke11a].

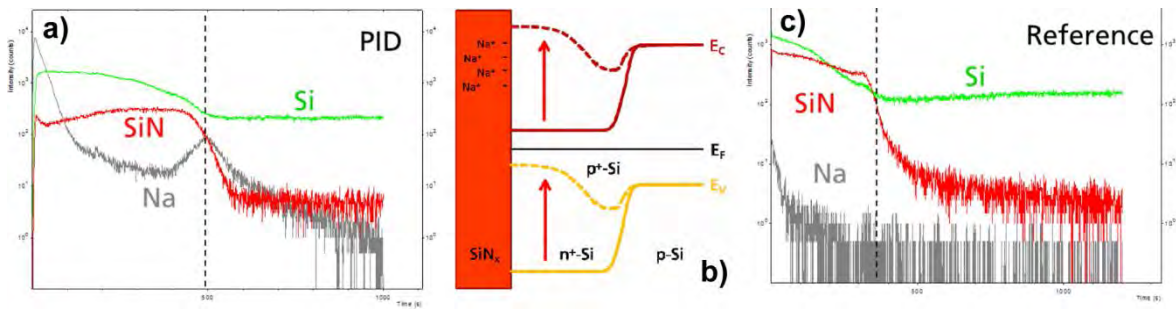
In-depth investigations of the cell-encapsulant boundary by means of Auger Electron Spectroscopy (AES) [Hacke11], see Fig. 6.2.10 b), detects sodium rich regions at the antireflection coating-Si interface.

Fig. 6.2.10: a) and c): Depth profiles recorded by means of time of flight SIMS (a) with, and c) without PID, respectively. c): AES imaging of the SiNx/Si boundary. b): Original band gap structure, and by PID changed energy levels (dashed lines) [Naumann12].

Also secondary ion mass spectroscopy (SIMS) [Naumann12], Fig. 6.2.10, with (a), and without (c) PID, respectively give evidence of Sodium ions trapped in the so called K-centers of the silicon nitride anti reflective coating. This positive space charge forms a double-layer with electrons changing the semiconductor's band gap structure, see middle drawing of the energy band model in Figure 6.2.10 b), causing the shunted paths in the p-n junction of the cell.

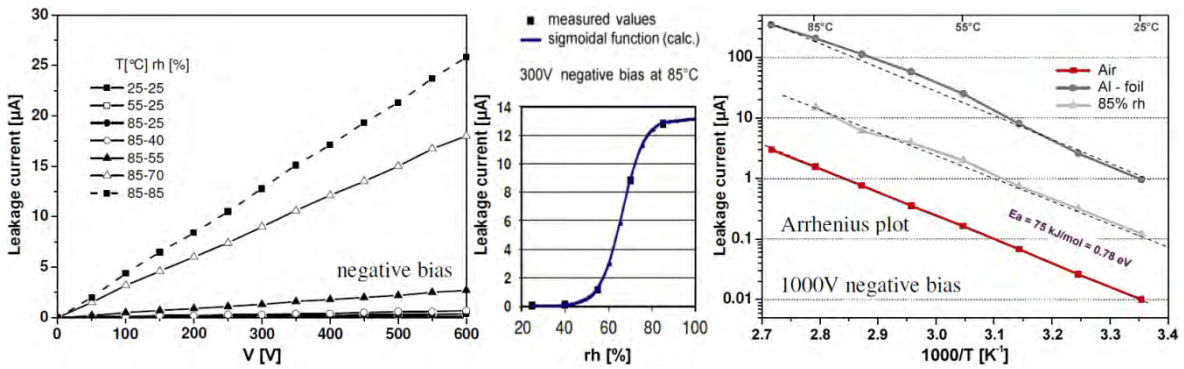
How severe the power losses due to PID are depends on the ambient conditions and system configuration, as well as module design parameters. For a given PV module design the value of the leakage current (and its time integral) can be an indicator for the PID effect in some circumstances. Figure 6.2.13 depicts measured values for the leakage current between the cells and the module frame over the applied voltage (with parameters temperature and rel. humidity), the relative air humidity at constant voltage, and reciprocal abs. temperature (with three different variants for contacting the module’s outer surface) [Hoffmann12].

Fig. 6.2.13: Measured values for the leakage current (LC) between cells and module frame. Left side: voltage dependency of LC, with parameters temperature and humidity. Middle: LC as a function of the humidity measured (squares) and approximation by a sigmoid function (blue curve). The effect of humidity in the climatic chamber is time dependent. This is due to condensation at the module [Mathiak12]. Right side: Arrhenius plot of LC with three different variants for contacting the module's outer surface: frame only, in (dry) air; front glass and frame additional covered with aluminum foil; frame only contacted, but 85% rel. humidity applied. Modified, from [Hoffmann12].

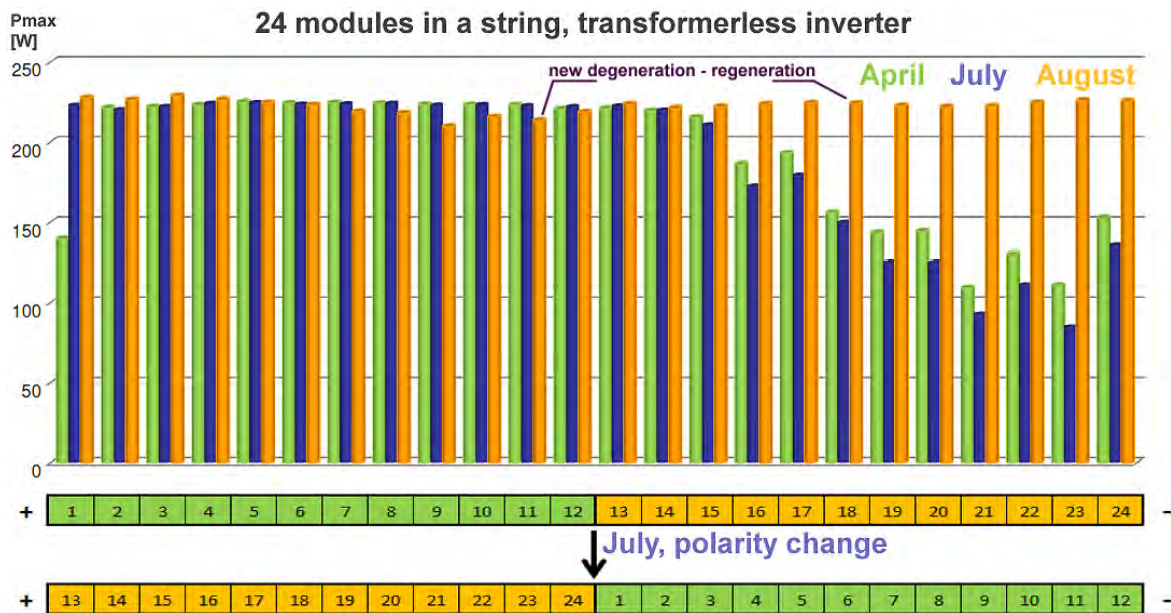
Figure 6.2.14: Measured power for individual PV modules at STC dependent on the module's position in the string. The power losses at negative potential are still increasing until the polarity is changed and recovery to the original P_{max} values takes place [Herrmann12].

Quick recovery is often possible within hours by applying a reverse voltage, low resistive contact to glass and frame, and at elevated temperature. PID occurring at higher temperatures (85°C) is much less reversible [Pingel12]. Some recovery can also be achieved by voltage and temperature alone, but with much longer time constants. Recovery can be achieved by applying reverse voltage during nighttime.

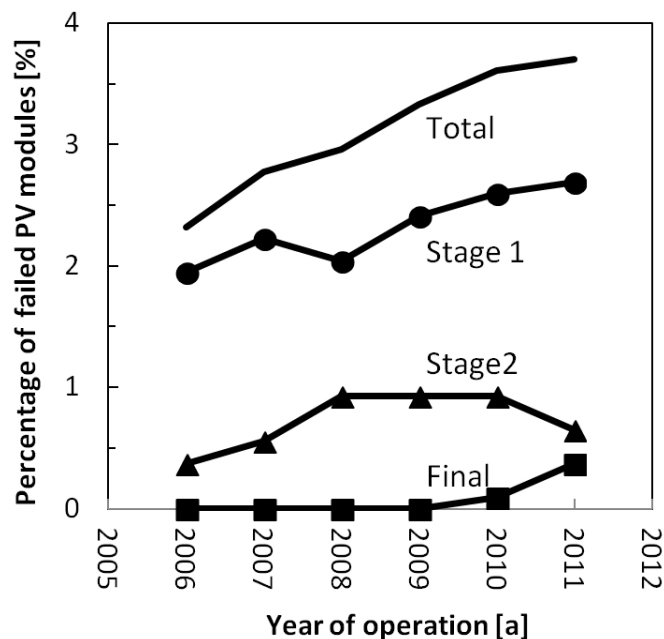
Figure 6.2.19 represents the trend in number of these PV module failures happening in a PV system. Bypass diodes play a very important role in conventional crystalline silicon PV modules as “safety valves” in case some electrical fatigue occurs in the cell strings.

Fig. 6.2.19: Annual trend in number of modules with cell interconnect ribbon failures happening in a PV system. The system consists of 1080 PV modules in total and was built in 2004.

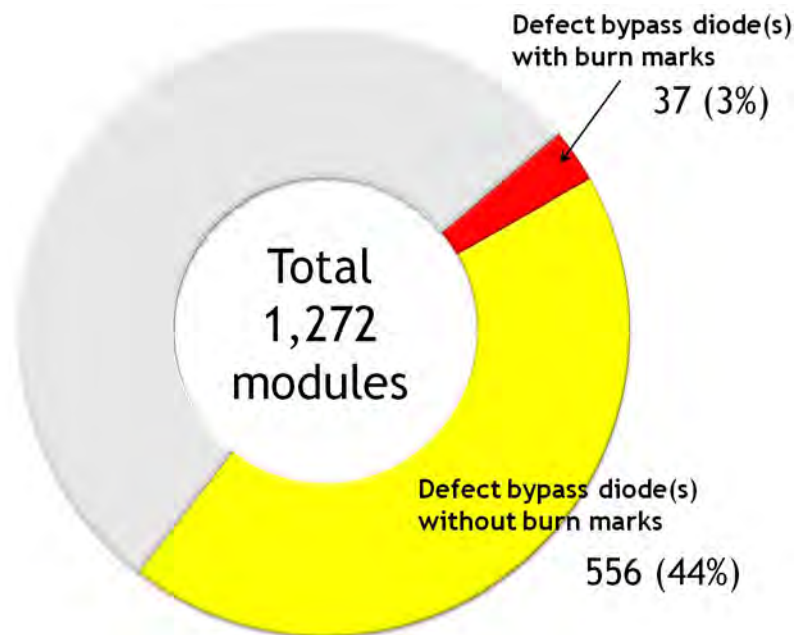
The system shows 47% of modules with defective bypass diodes, see Fig. 6.2.21. 3% of the defective PV modules also show burn marks on sub-modules. The sub-modules with burn marks always have defective bypass diodes.

Fig. 6.2.21: A result of bypass diode check for 1272 180 Wp PV modules of one type. The diagram shows the number and percentage of PV modules with one or more defective bypass diodes. The PV modules have been in the field for about four years.

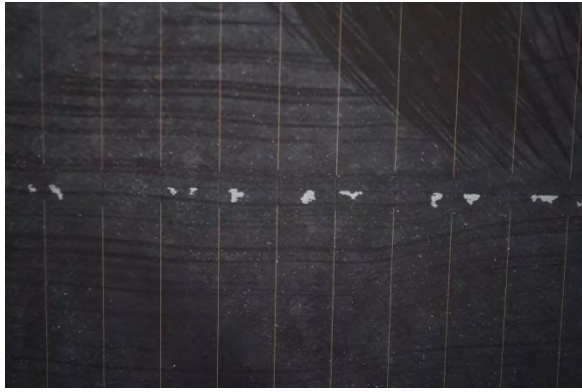
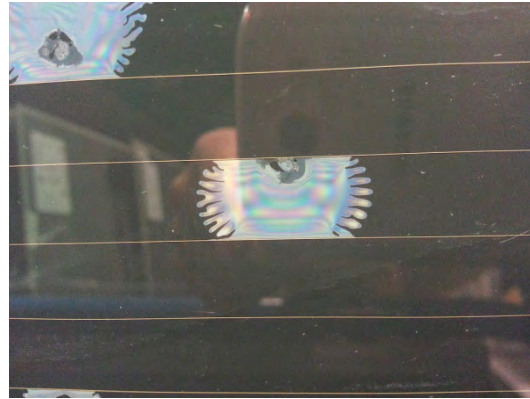
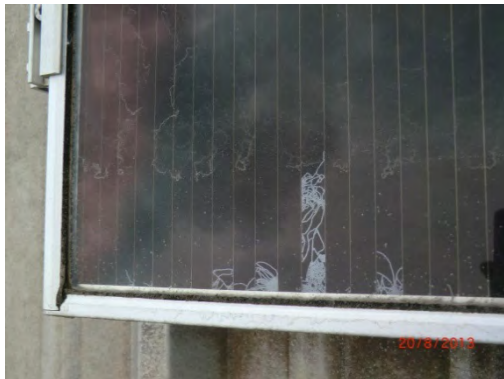
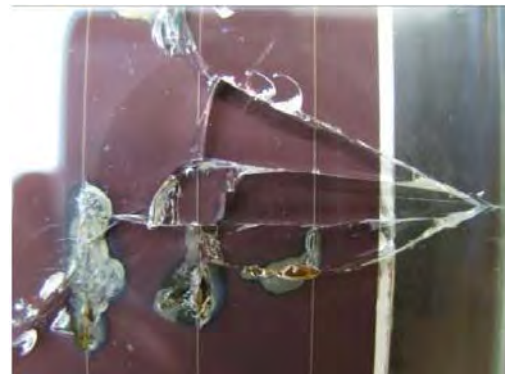
Thin film PV modules	Crystalline silicon PV modules
Formation of hot-spot shunts	Cells are very sensitive to junction breakdown if operated under reverse bias voltage. Visual appearance of damages can be very different (pins, small areas pots, worm-like trails). Figure 6.3.3 gives some examples of hot-spot damage observed during laboratory hot-spot testing (IEC 61646).	Cells are tolerant against reverse bias operation if protective measures with bypass diode are well designed.
Measures for prevention of hot-spot heating	Formation of hot-spot shunts cannot be avoided. The damage is clearly visible and is normally spread across the affected group of cells. Various technologies apply an additional laser scribe to divide cells into electrically isolated parts. This measure shall reduce potential hot-spot damage.	Bypass diodes are implemented in the interconnection circuit of cells. Reverse voltage at a shaded cell is limited to a non-critical value to prevent p-n junction breakdown. For example, 20 serially connected cells per bypass diode can lead to reverse voltage up to approx. -12 V.

Fig. 6.3.3: Module damages and failures observed for hot-spot testing of thin-film modules in accordance with IEC 61646: a) Formation of hot-spot shunts along a laser scribing line, b) Formation of hot-spot shunts at the cell interconnection associated with large-area cell damage, c) Formation of hot-spot shunts associated with worm-like cell damage, d) Glass breakage through high temperature gradient and not tempered glass [Wendlandt11].

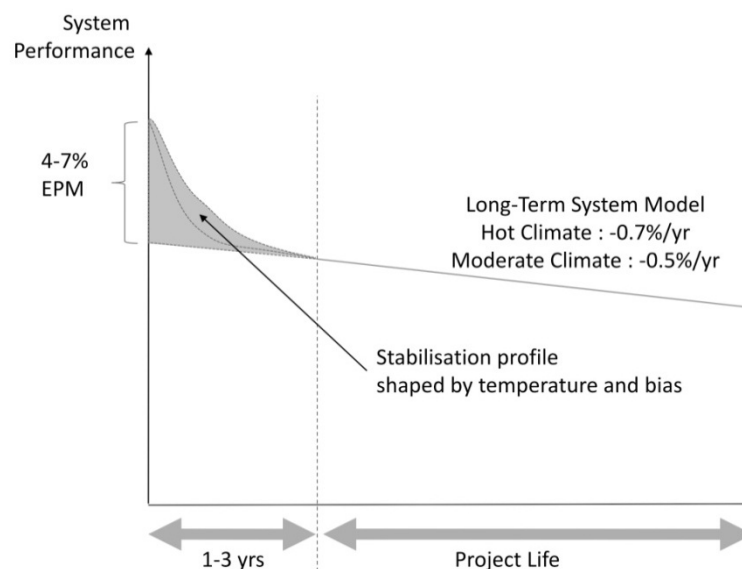
Starting in the second year of operation and every year after, a yearly degradation rate of 0.5 to 0.7% can be expected, depending on temperature climate conditions, see Fig. 6.4.2.

Fig. 6.4.2: Time dependence of degradation caused by Cu diffusion from the back contact into the CdTe absorber [Strevel12, modified]. EPM is the abbreviation for Engineered Performance Margin.

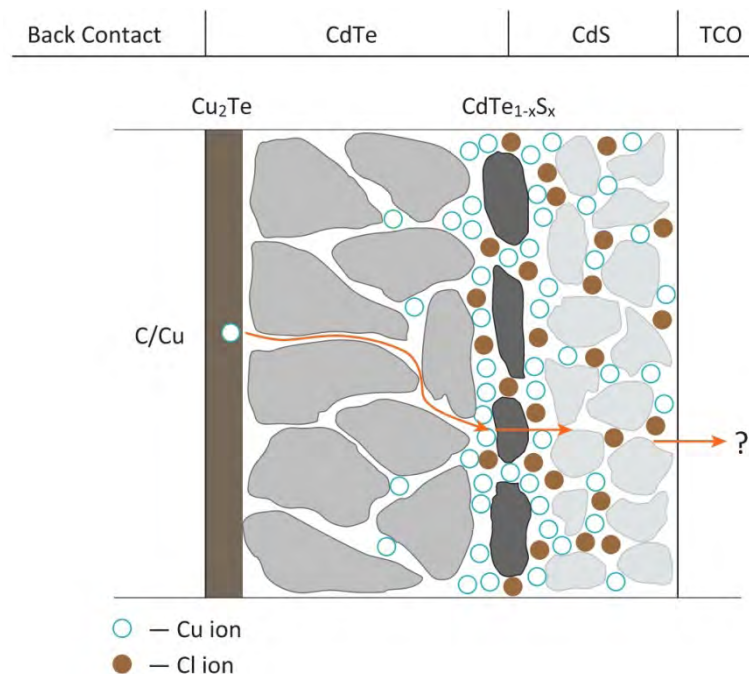
Both phases are attributed to grain boundary diffusion of copper from the back contact as discussed by Cahen et al. [Cahen01], see Fig. 6.4.3. Cu from the Cu-rich back-contact area migrates through the CdTe/CdS interface. The process of

Fig. 6.4.3: Copper migration through a CdTe device [Strevel12].

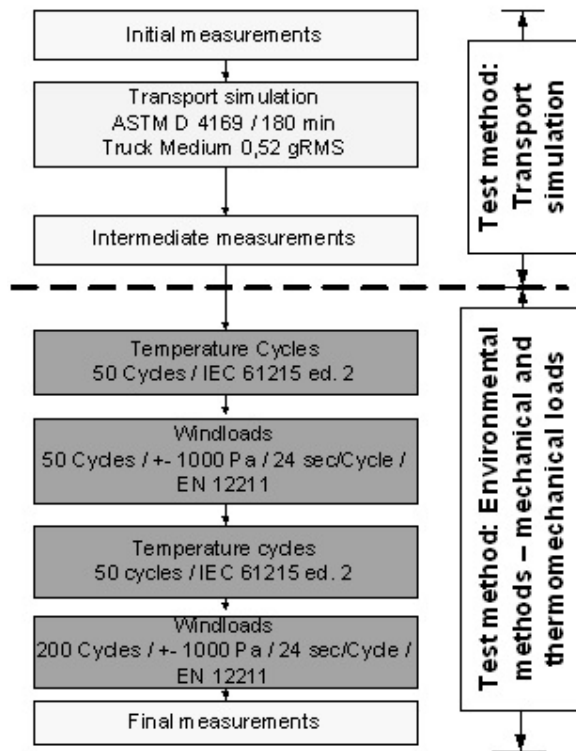
According to the development and results of the I V-measurements, the transport simulation of the two complete module stacks according to ASTM D4169/4728, resulted in changes of the electrical power at a maximum degradation of $\Delta p_{MAX} = 1.5\%$. The adjacent conducted environmental tests (thermal cycling, dynamic wind loads) induced after the transport tests a power degradation up to $\Delta p_{MAX} = 2.8\%$.

Fig. 7. 1.2: Test pattern for combined transport and environmental simulation to determine the longtime behavior of the modules.

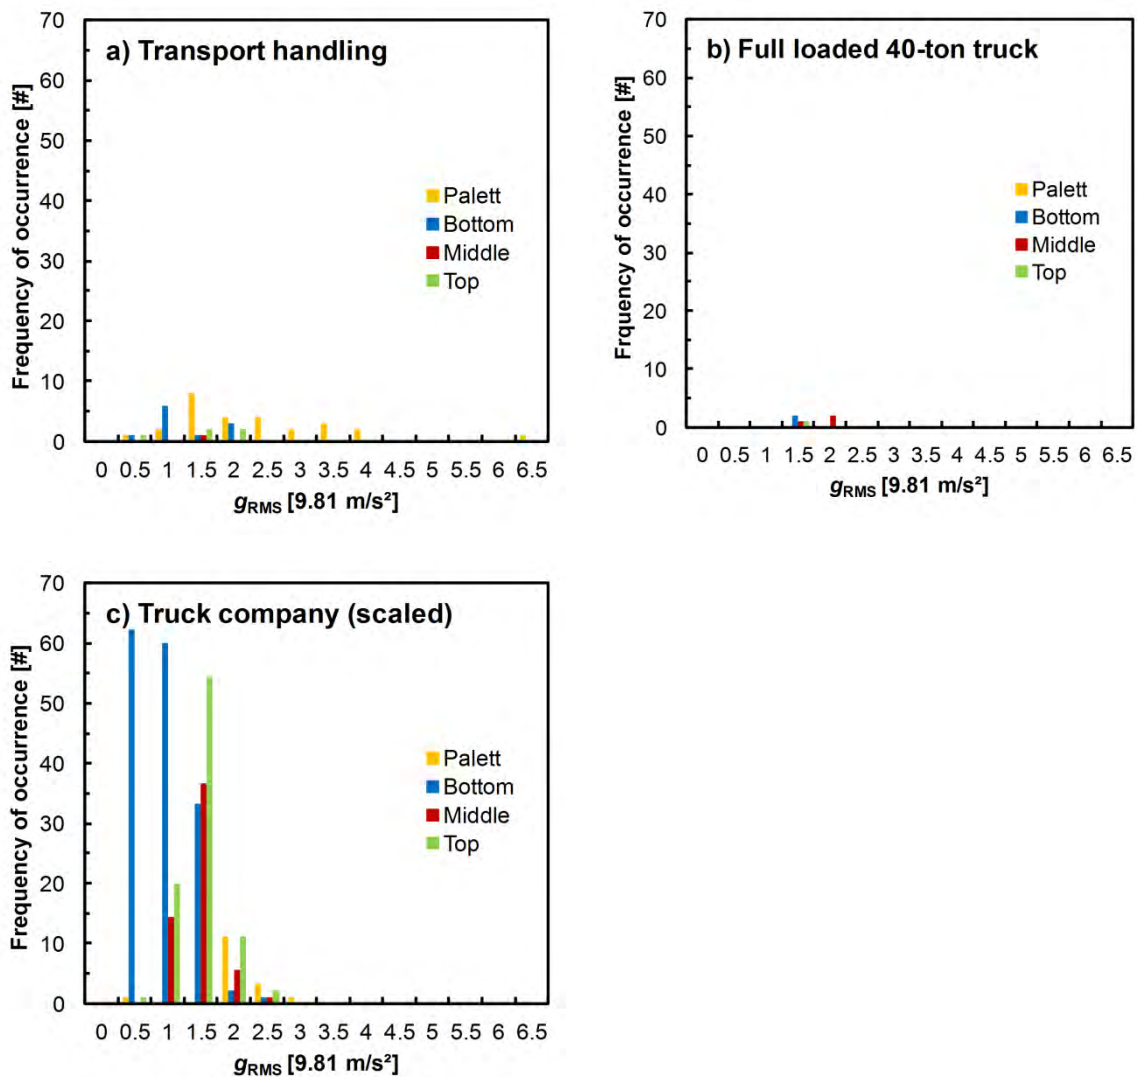
The shock intensity and frequency for transport handling, a full loaded 40-ton truck and transport done by a shipping company with an unknown truck type are compared in Fig. 7.1.4. The results show that during the transport handling shocks with the highest intensity occur to the pallet, but not to the PV modules. The full loaded 40-ton truck transport shows as expected shocks with low intensity and low frequency. The transportation with the shipping company shows the highest shock intensity for the modules and the highest shock frequency. So we focus on that worst case transport (truck company). The maximum number of cell cracks per module after the transport of a module package is two if the manufacturer's packaging is used. There is still the uncertainty that it cannot be differentiate in the test between cell cracks caused by the transport handling and the transport itself.

Fig. 7.1.4: Measured shock frequency for a) transport handling, b) transport in a fully loaded 40-ton truck, and c) transport with a truck company driving the same distance. Palett, bottom, middle, and upper indicate the measurement at the module positions in the bottom, middle, and upper part of packaging unit.

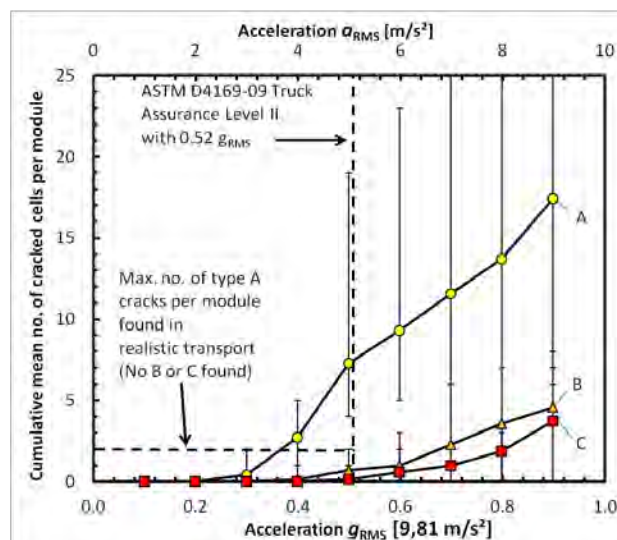
Fig. 7.1.6: The graph shows the cumulative mean number of solar cells with new cracks of type A, B, and C after a 15 min. noise test using the ASTM D4169-09 Truck PSD-spectrum [ASTM1]. The RMS acceleration amplitude a_{RMS} of the PSD-spectrum is varied in this experiment. The error bars show the maximal variance of the set of tested PV modules.

The ASTM D4169-09 Truck Assurance Level II [ASTM1] is a well fitting PSD-spectrum to simulate the vibration of PV-modules in a PV module stack during transportation. However if we look into Fig. 7.1.6 and compare the number of cell cracks found in this test at the level $g_{RMS} = 0.52g$ of the standard we find that even after 15 minutes there are many more cell cracks than found in the realistic tests. If we choose a level of maximum 2 cell cracks as found in the realistic transports we should choose a mean test acceleration intensity of 3-4 m/s^2 ($g_{RMS} = 0.32-0.41g$) for the test. Moreover we find a clear threshold of mean acceleration level for the first occurrence of a cell crack in all PV modules. Below 3 m/s^2 mean acceleration intensity no cell cracks occurs, below 4 m/s^2 no type B cell crack occurs, and below 5 m/s^2 no type C cell crack occurs. The time dependence of the cell cracking behaviour is still under investigation.

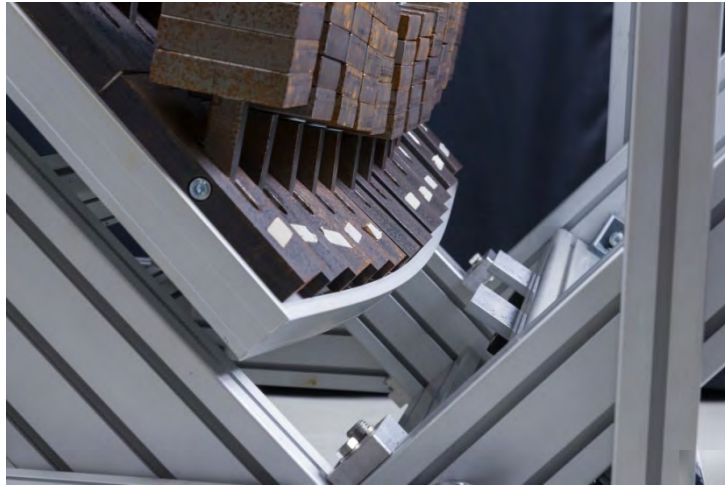
Under a load of only 15% of initial load and a two-point load application, modules already revealed weaknesses from lack of frame rigidity, with deformations of up to 5 mm. The slight deformation of the frame is also greatly influenced by the loosening of the adhesive bonds between the frame and the glass surface. With different frame designs we observed a single specimen with screws broken off from the corner clamps.

Figure 7.2.1: New test apparatus for snow load testing at TÜV Rheinland 2012: Application of load elements causing the bending of a PV module frame.

It was found that modules with silicone-based adhesives can resist loads of up to nearly 500 kg (~ 3 kPa) without any frame bending or permanent damage, while modules with the same dimensions and frame design but with tape-based adhesives allow frame bending and a glass breakage at lower loads between 230 kg – 360 kg (1.4-2.3 kPa). The loads were applied to 2/3 of the module length.

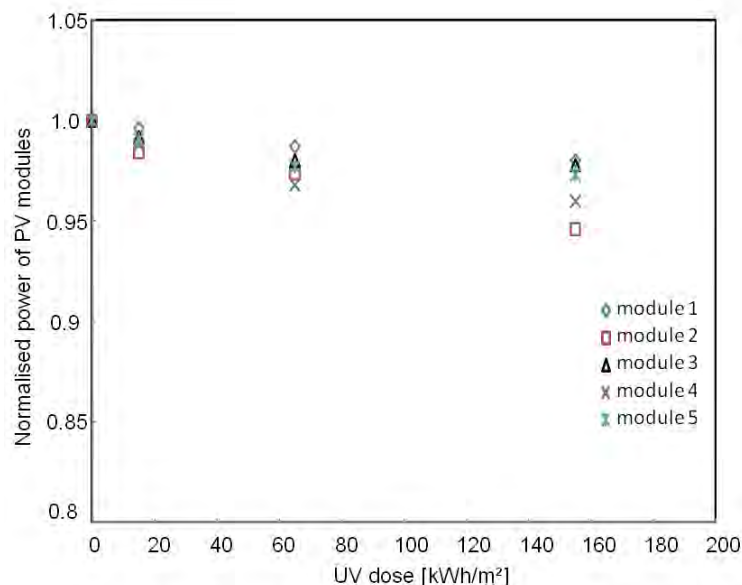
It is clear that the output power degradation of five modules do not reach 5% after 15 kWh/m^2 UV irradiation according to the IEC 61215 standard. However, two samples of five modules show slight changes of power after 20 kWh/m^2 irradiation dose. The power degradation of one of the modules is more than 5% after 160 kWh/m^2 irradiation. This result illustrates failures of module electrical performance and polymeric materials. Two modules show an apparent trend of power degradation over long term UV irradiation.

Fig. 7.3.2: The peak power degradation of monocrystalline PV modules after UV irradiation exposure under a simulated UV light source is shown. The module temperature is between 75°C and 85°C .

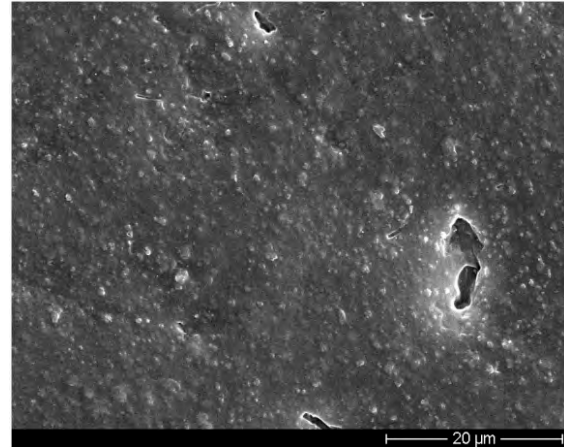
However, visual inspections do reveal corrosion and erosion effects similar to the ones found on samples taken from the field. The seal, the surfaces of the anodised aluminium frame and the anti-reflective coatings of the glass are slightly affected. Potentially critical findings are small, 10 µm pores in the backsheet (see Fig. 7.4.1 and Fig. 7.4.2), resulting from the chemical reaction of the outer layer of the backsheet with ammonia.

Fig. 7.4.2: Scanning electron microscopic image of a backsheet after the ammonia test. Small pores (10 μm in diameter) can be seen.

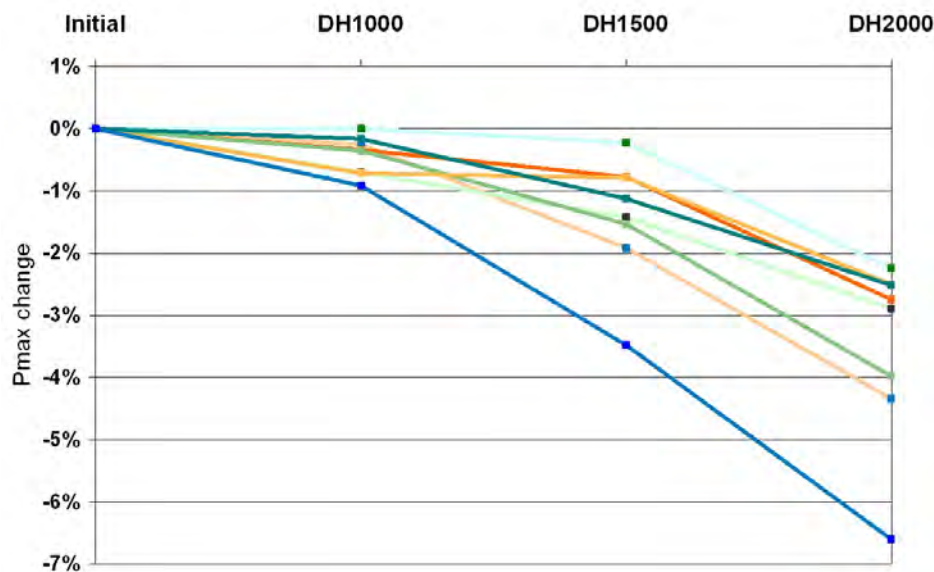
With qualification testing, the tests showing the largest impact on PV module performance are temperature cycle tests and tests in which the temperature and humidity act on the modules. Figure 7.6.1 shows the change of output power of 8 modules of the same type after 1000 h, 1500 h, and 2000 h of damp heat. Obviously

However, even after exposure to 2000 h of damp-heat, which is twice the time required by IEC 61215, seven out of eight modules showed less than 5% power degradation. The degradation though was clearly measurable and could serve the comparison with the degradation outdoors.

Fig. 7.6.1: Change of output power of 8 PV modules of same type after 1000 h, 1500 h, and 2000 h damp-heat test at 85°C/85%RH [Herrmann11].

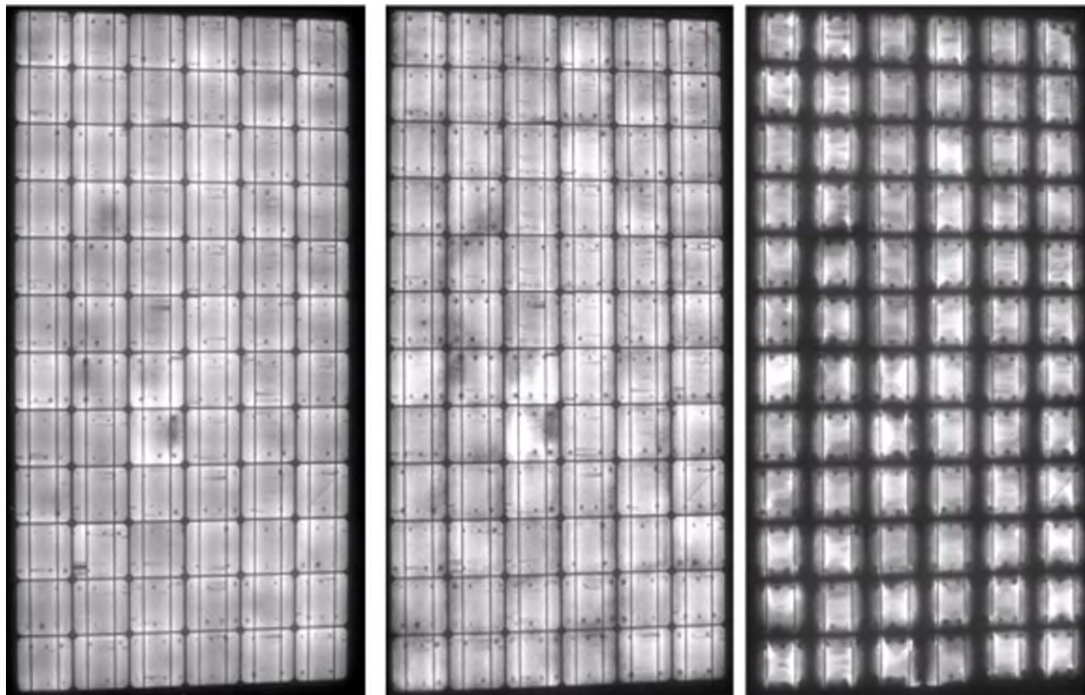
After 2000 h of damp heat the power degradation of another module amounted to 4%, as is also visible in the EL image in Fig.7.6.2. A further extension of the damp heat test to 3000 h causes severe cell degradation. The output power of the module drops by 28%. In the EL image the outer parts of the cell are completely dark. Evidently the moisture diffused through the rear side of the module in the gaps between the cells caused cell corrosion on the front side of the cell. Comparing such results with outdoor degradation behaviour, we find the module obviously overstressed after 3000 h since modules featuring such intense degradation by water vapour ingress can hardly be found in the field even after decades of exposure. Nevertheless, despite one single module which showed some browning (compare 5.3.1) neither delamination as described in chapter 5.3.5 and 5.3.6 nor loss of adhesion strength could be observed.

Fig. 7.6.2: Electroluminescence images of a module after 1000 h, 2000 h, 3000 h of damp heat (from left to right) at 85°C/85%RH, featuring -1%, -4%, and -28% degradation of output power, respectively [Herrmann11].

When attempting to demonstrate that a module design has greater durability, a common practice has been to increase the damp heat test to 2000 h, 3000 h or more. However, 3000 h has been reported to cause failures that have not been reported in the field. E.g. Fig. 7.6.2 shows a detachment of the silver front side fingers of the solar cell which has not yet been reported from the field. Thus, it is unclear whether the application of 3000 h of damp heat to a module with a breathable back sheet has any value toward predicting life in the field. However, modules that attempt to keep all moisture out by using two sheets of glass with an edge seal age in a very different way and a recent paper estimates that 3000 h may be appropriate for quantifying the movement of moisture through the edge seal to simulate close to a 20-year in-field exposure [Kempe12]. Nevertheless, the value of 3000 h of damp heat testing as a predictor of field performance has not yet been reported.

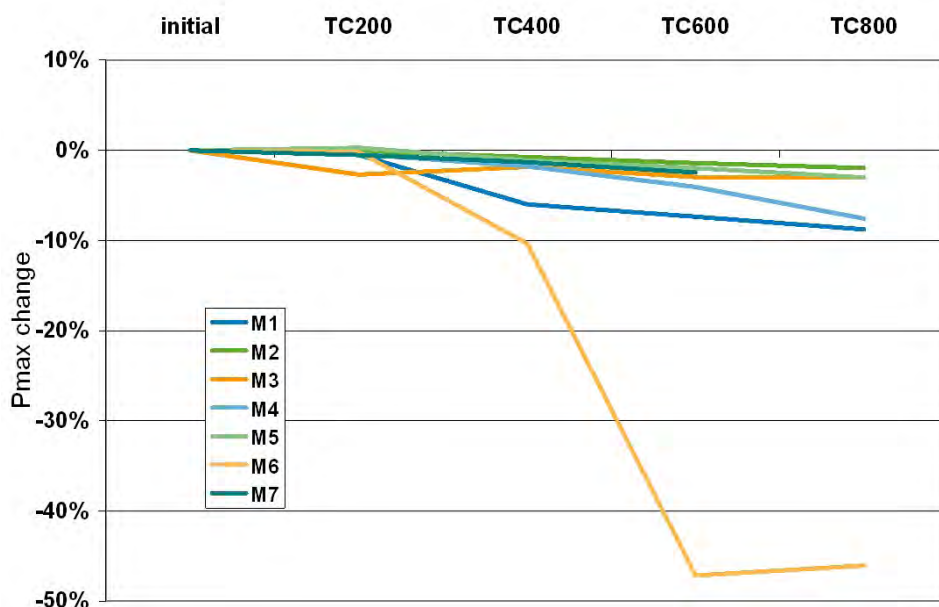
An extension of the thermo-cycling (TC) test leads, with respect to loss of output power, to comparable results, although the type of stress is different. Figure 7.6.3 shows the results of 7 crystalline modules manufactured by different companies and undergoing TC tests for 200, 400, 600, and 800 cycles, with re-measurement after each subtest. Again, at twice the stress, the power loss for all modules remained within the margins set by IEC 61215. Another 200 cycles were needed in order to

observe significant degradation with one of the modules. Three modules showed less than 5% power degradation even after 800 cycles.

Fig. 7.6.3: Change of power of 7 modules of different types after 200, 400, 600, and 800 temperature cycles [Herrmann11].

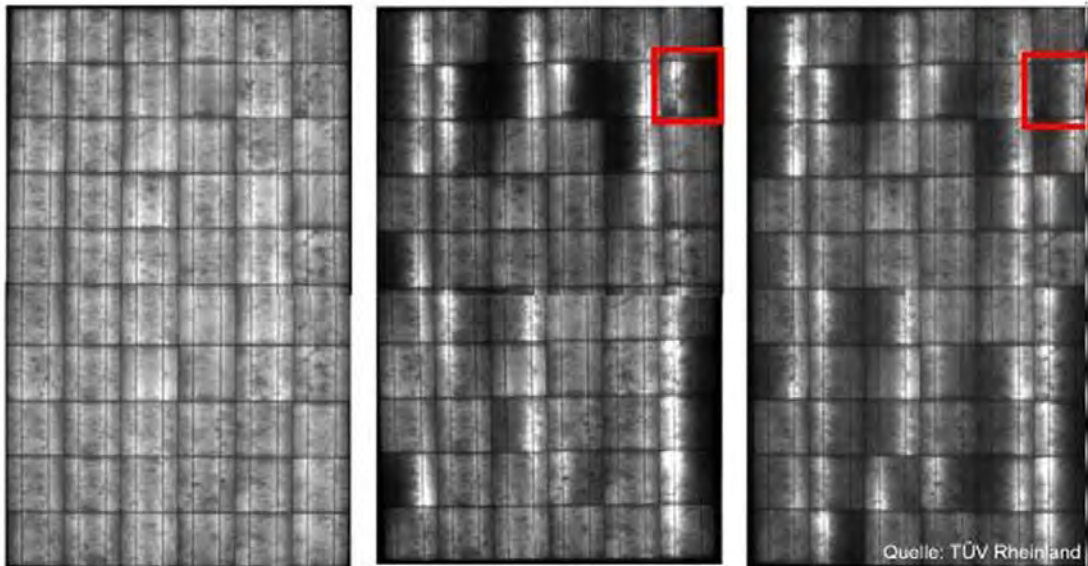
Frequent changes in temperature are known to wear out the cell interconnections. Temperature cycle tests reveal weak connections within modules. Figure 7.6.4 shows EL images of modules after 200, 400, and 600 cycles, respectively. With an

increasing number of cycles and after 200 cycles, an increasing number of busbars become disconnected, as is evident from the dark areas. While some of these disconnections may not last permanently (see red markers), in general the output power will decrease as the number of cycles increases. The result is further degradation. Due to the inhomogeneous current distribution between cells with broken busbars, high temperatures or even hot spots can occur. Loose contacts can also cause arcing.

Fig. 7.6.4: Electroluminescence images after 200, 400, and 600 temperature cycles, as described in IEC 61215. Dark areas indicate disconnection of busbars that may not always be permanent, see red markers [Herrmann11].

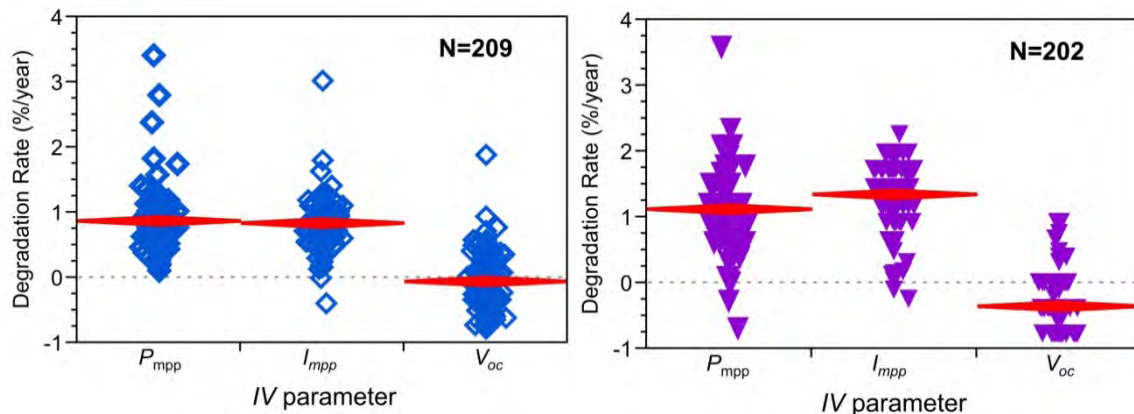
Modules that have failed and been returned to the manufacturer are not the only thing to be considered; modules are usually observed to degrade slowly in the field. Figure 8.1 summarizes ~400 reports in the literature of degradation rates for silicon modules [Jordan13]. The degradation is dominated by a loss of short-circuit current. In most cases, the researchers observed that this decrease in short-circuit current is associated with discoloration and/or delamination of the encapsulant material. Thus, both statistics on returns of modules and statistics on slow degradation appear to be correlated with mechanisms that can be observed visually. Although there is much value in more sophisticated investigations, the simplicity of collecting visual observations allows collection for a very large set of modules, enabling us to correlate the environment with the types of changes that are occurring. We propose to collect the data in a systematic format, greatly simplifying the analysis.

Fig. 8.1: Degradation rates of the maximum-power-point values for power, current and voltage for monocrystallineSi (left), multicrystalline-Si (right). As a guide for the eye, dashed lines indicate no degradation. A negative degradation implies improvement. The symbol N represents the number of PV modules of the statistic [Jordan13].
